Convegno
Fine Progetto SloMove

Monitoraggio di movimenti gravitativi
Esperienze applicative e ricerca nell'arco alpino

INTEGRATION OF DIFFERENT MONITORING TECHNIQUES: THE EXAMPLE OF ROSONE LANDSLIDE (WESTERN ALPS)

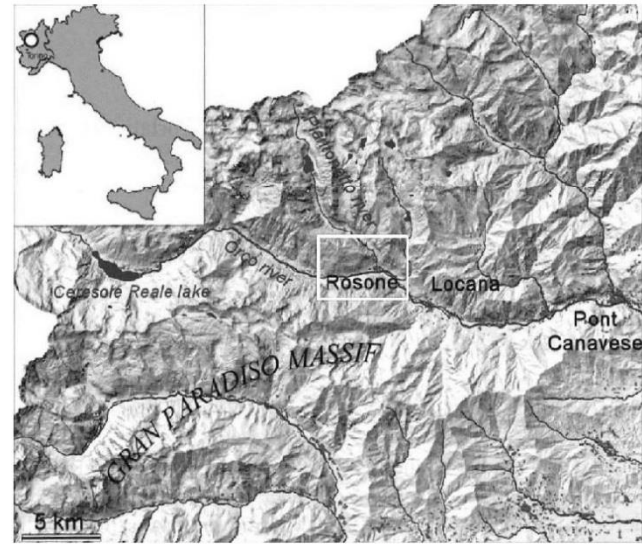
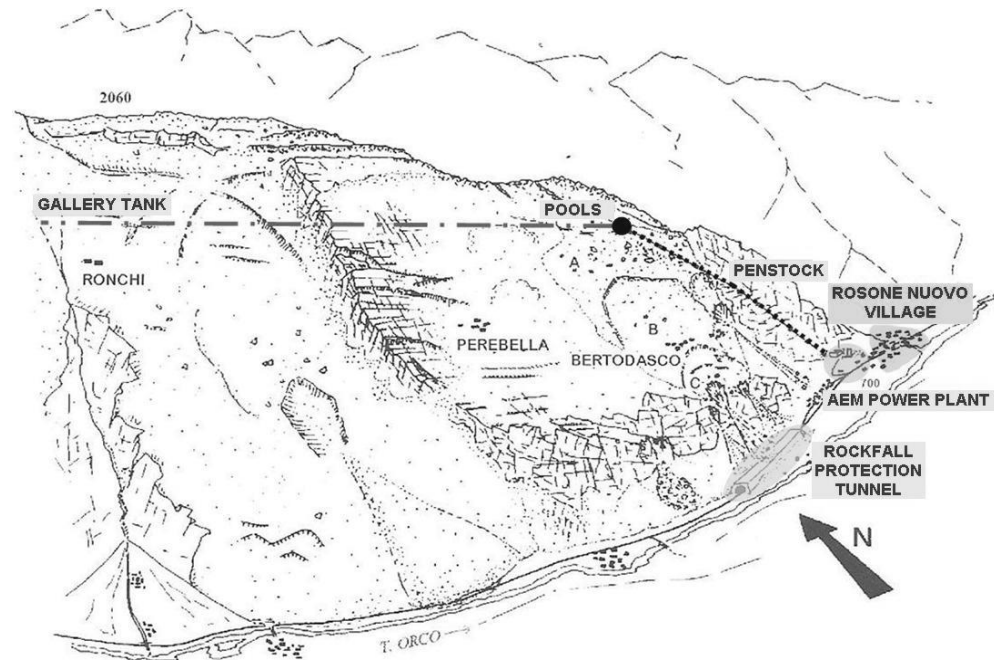
- ✓ The Rosone landslide is located in the Orco Valley (NW Italian Alps). It is a larger deep seated deformation (5,5 km²)
- ✓ The landslide affects the penstock of the near hydroelectric plant.
- ✓ The landslide was well monitored since 60's and it was studied by many authors (Ramasco et al, 1989; Chiriotti, 1997; Forlati et al, 2001; Bonnard et al, 2004; Binet et al, 2007, Pisani et al, 2010; ARPA Piemonte, 2012) that provides to assess the geomechanical, geomorphological and hydrogeological settings and to set up different models to predict the possible evolution and scenarios of risk in case of collapse.
- ✓ It is one of the most studied, modeled and monitored landslide in Piemonte Alps, due to catastrophic consequence of a collapse that may affect the penstock

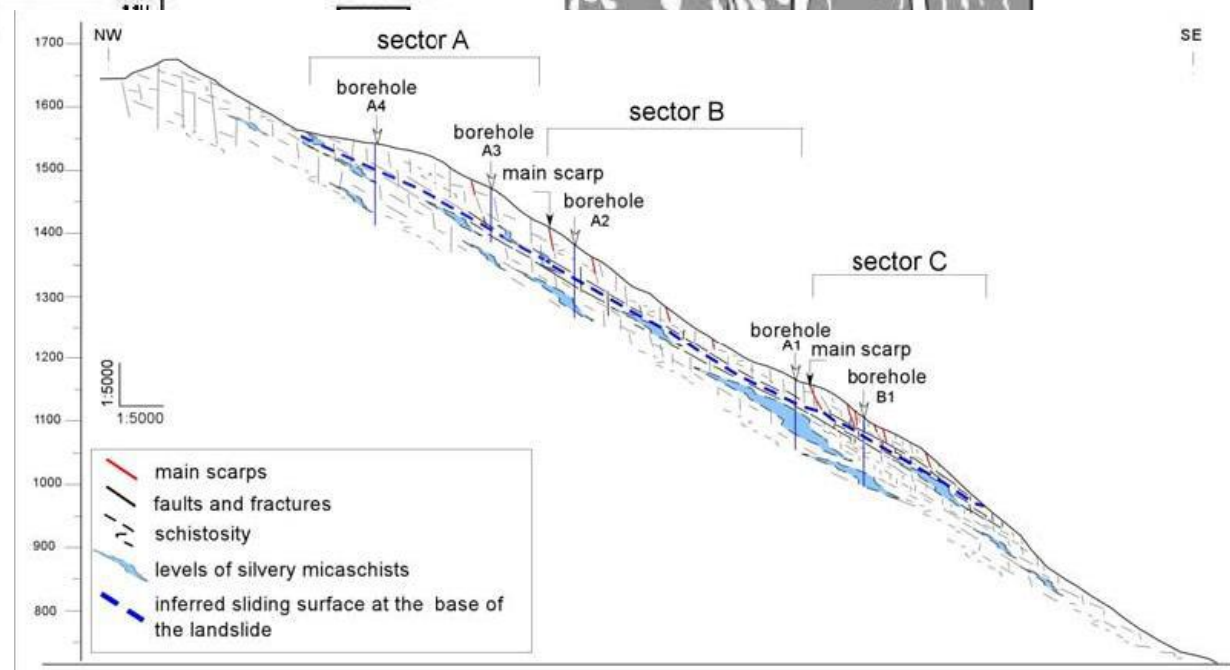
3.3. Geomechanical Settings

- Reflection seismic surveys
- Down holes
- Boreholes (100-120 m)

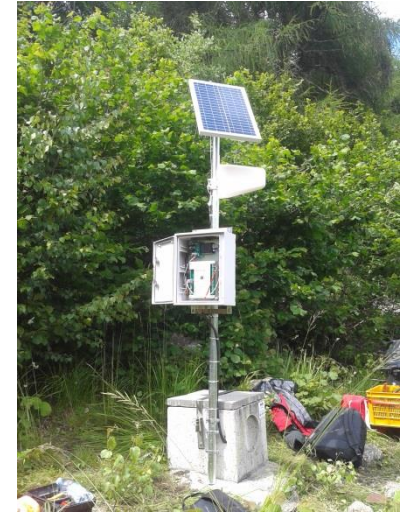
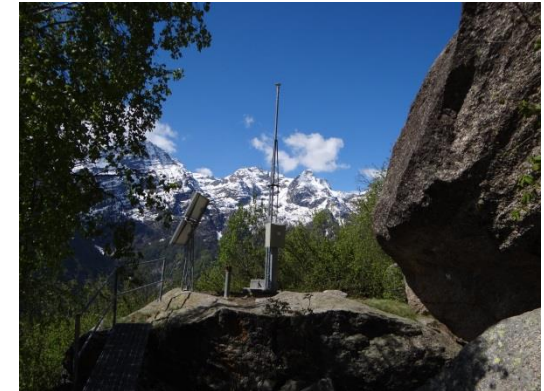
4.2. New Monitoring System

- n. 4 **inclinometers with manual reading** (measure of deep movements);
- n. 1 **inclinometers with automated data recording** (continuous measure of the movement along the sliding surface);
- n. 7 **laser distantiometers**;
- n. 24 **GPS with manual reading**;
- n. 5 **GPS stations with continuous measures**;

monitoring system for knowledge purposes

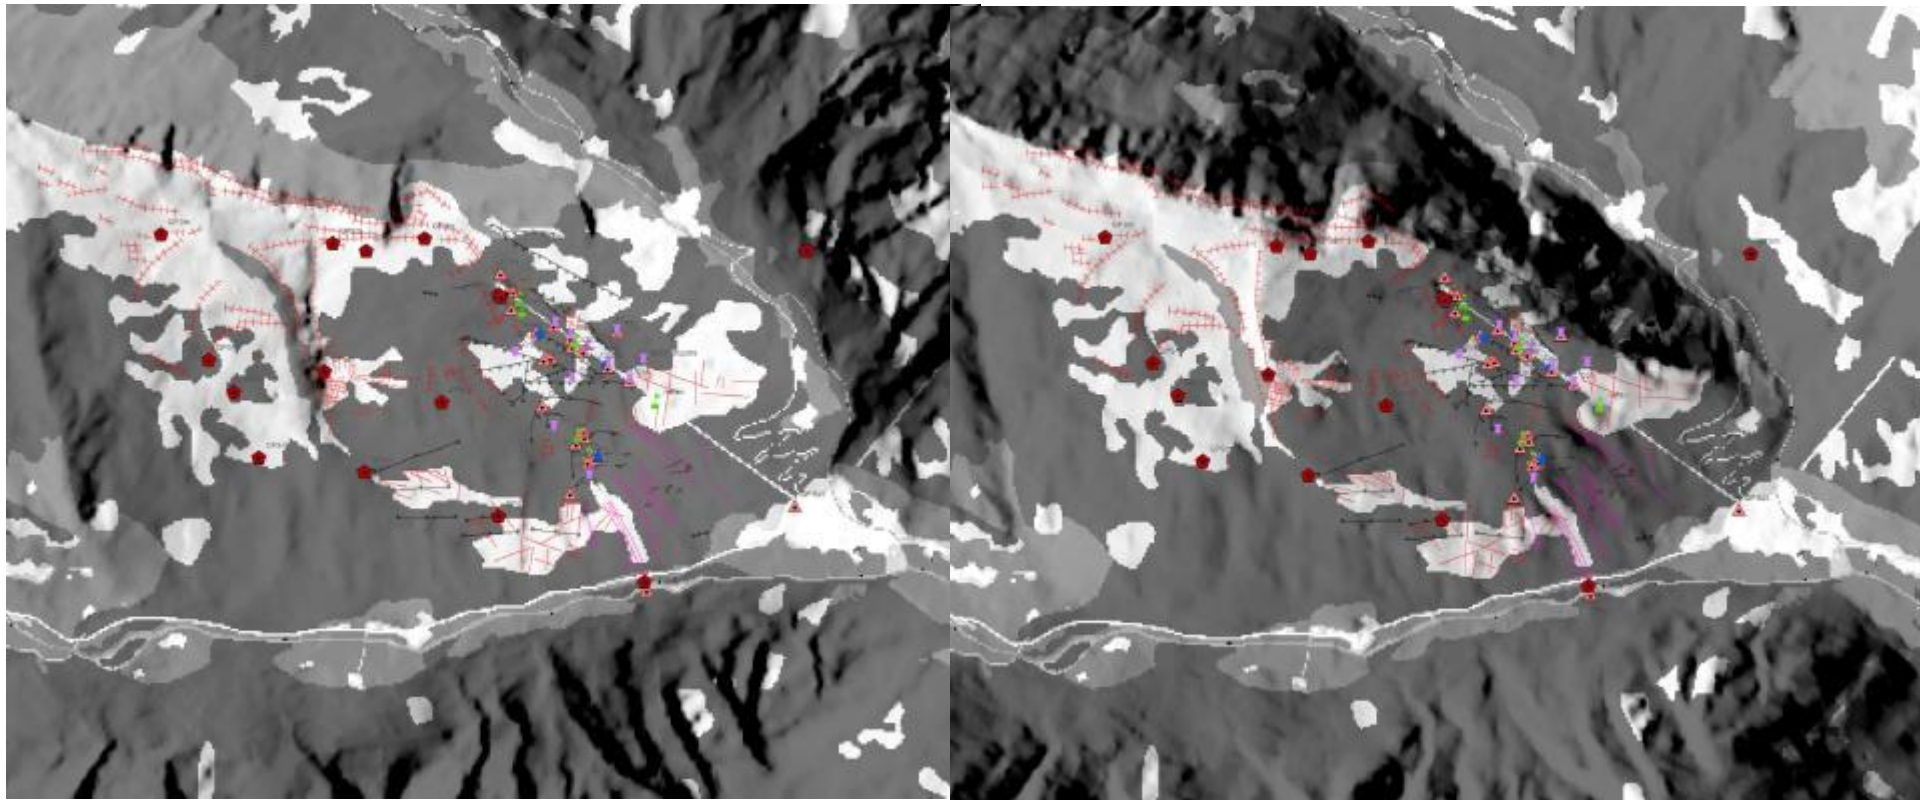
Prediction of the PSI distribution through the CR-Index .
White areas: probability up to 90% to find PSI

The C area is not suitable for a PSI processing

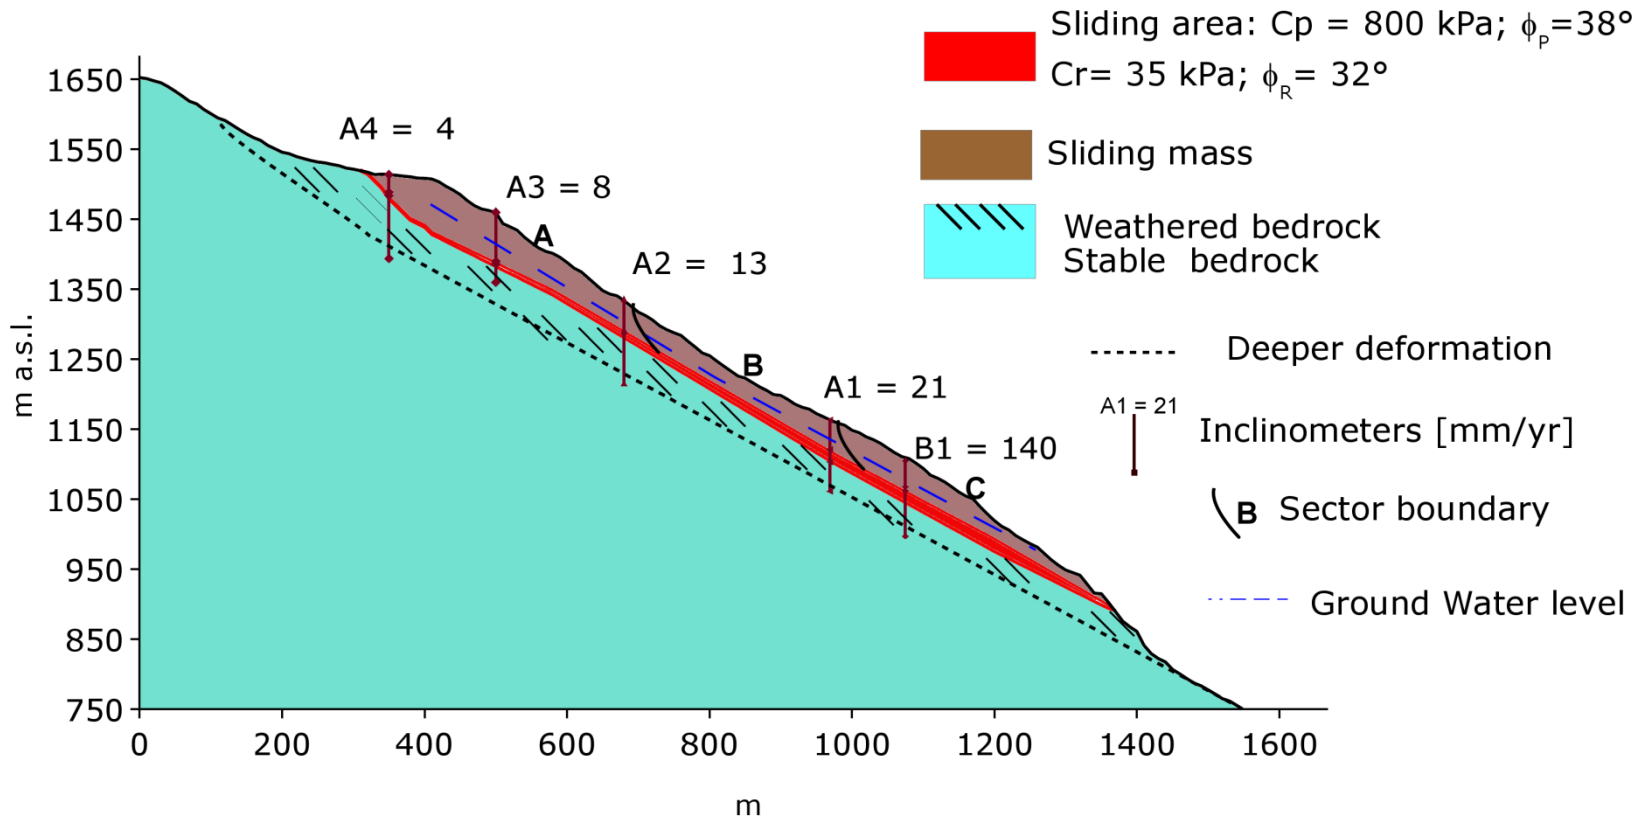
✓ Velocity registered by the different monitoring systems

Landslide sector	Velocity mm/yr			
	GPS	Optical	Inclin.	PS Data
A (a1 - a2)	12	5	< 10	4 a1 - 10 a2
B (b1 - b2)	20	15	10 - 30	8 b1 - 20 b2
C	45	38 - 43	n/a	n/a
Period of analysis	2001-2011	2001-2011	1991-2008	2003-2009

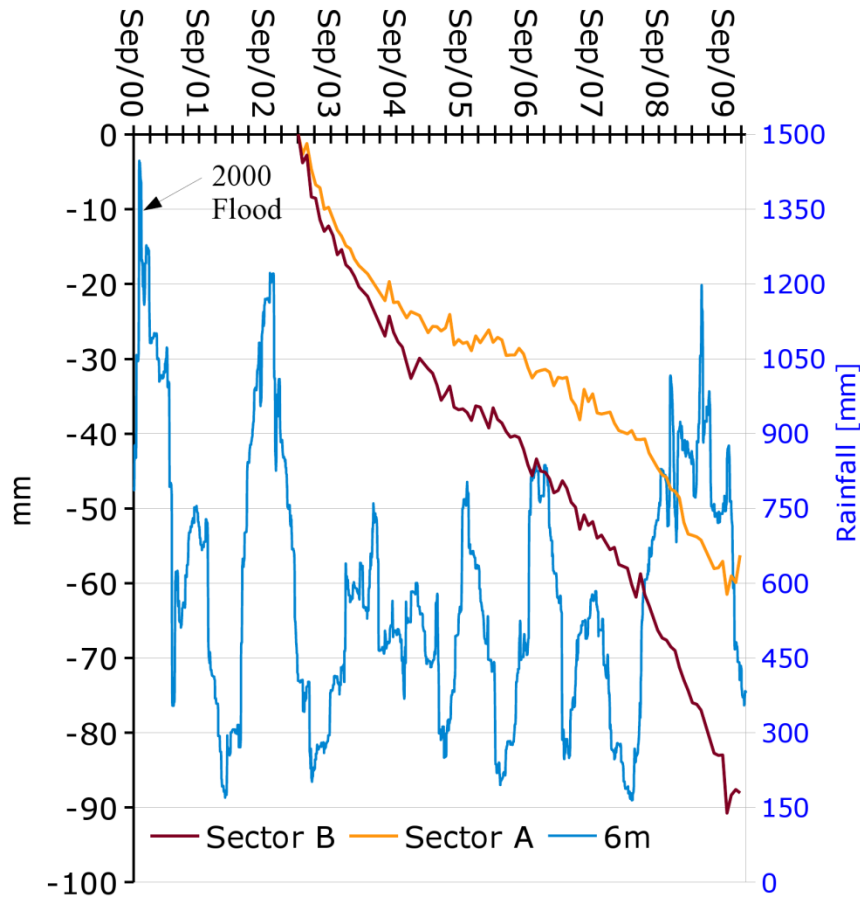
PS Time series (2003-2009 *RADARSAT* descending data) of the sectors A and B compared with 6 months (6m) cumulated rainfall (2000-2009)

The TS show a weak change in the trend

- Slow movement in the period 2005-2008 may be related to dry period;
- No critical events during PS monitoring (2003-2009)

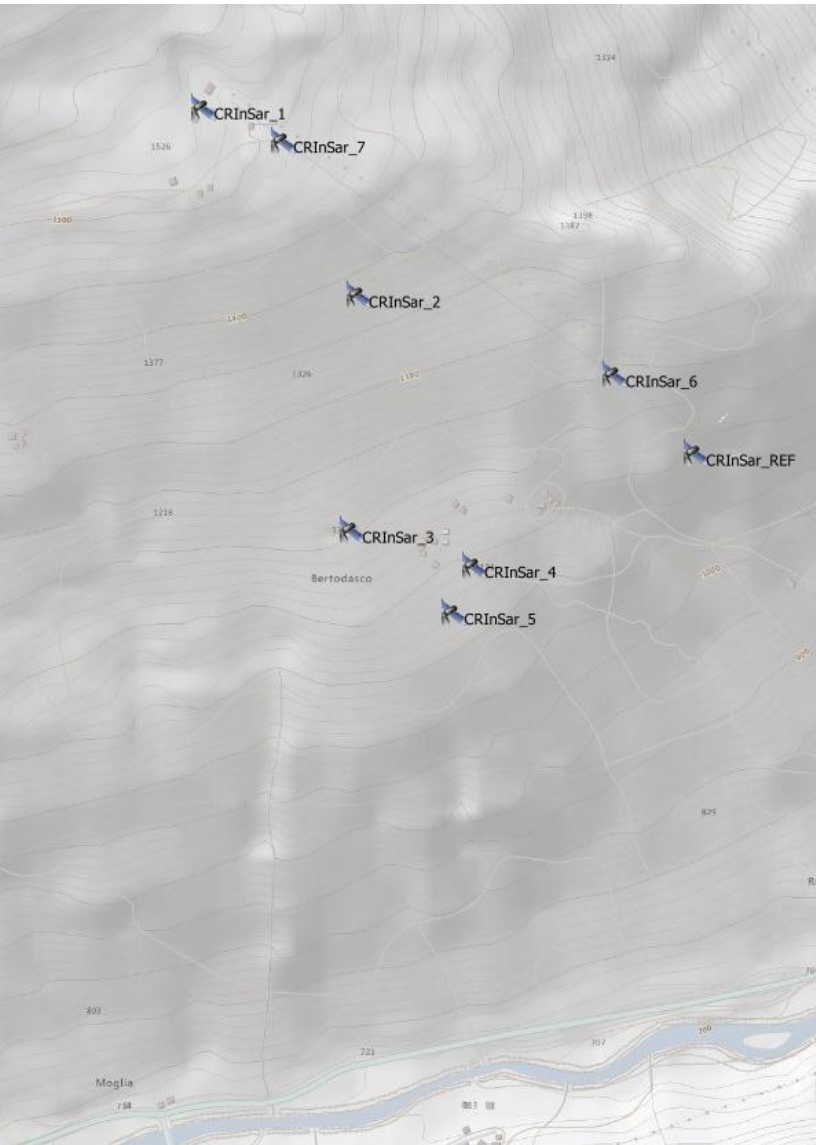
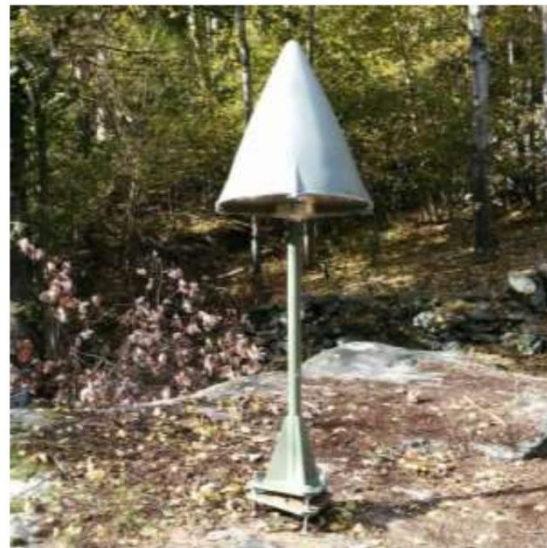
4.3. CORNER REFLECTOR

□n. 8 **Corner Reflector** for the application of Corner Reflector Interferometric SAR (CR-InSAR) technique;

PUNTO DI MISURA	Nome	CRInSAR3		
	Posizionato da	Tele-Rilevamento Europa T.R.E. s.r.l.	Data	22/10/2014
DESCRIZIONE	Il punto di misura è stato materializzato utilizzando un affioramento roccioso pre-esistente.			
COORDINATE	Northing [m]	Easting [m]	Quota ellissoidica [m]	
WGS84-UTM32N	5032894,61	375145,803	1256,547

Si consiglia una verifica della visibilità in relazione alla presenza di alberi sul lato ovest del riflettore (possibile impedimento in geometria ascendente).
